THE ROYCE FAMILY FUND
8 SOUND SHORE DRIVE, SUITE 140 GREENWICH CT 06830
CHARLES M ROYCE, PRESIDENT

THE TOWER STREET SCHOOL REUSE STUDY 2021-2022
SUMMARY REPORT

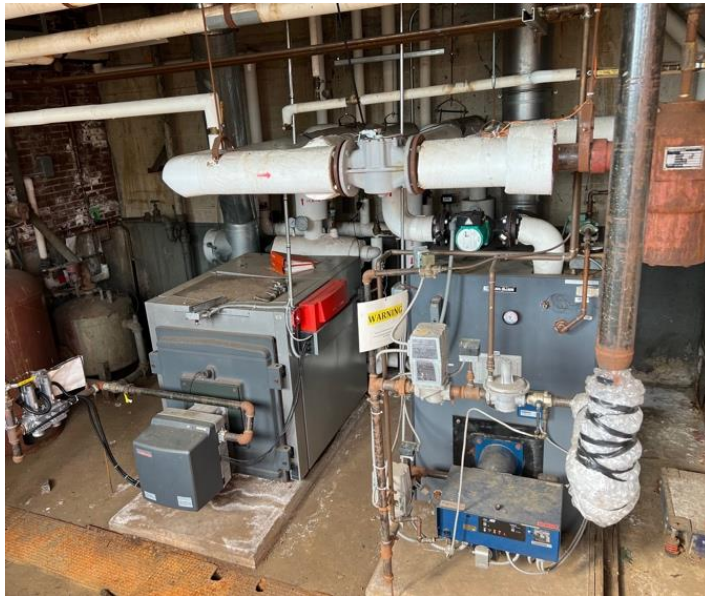
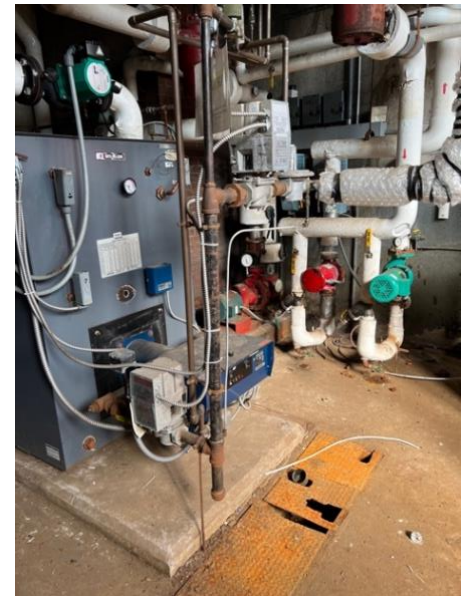
Allied provided two options to address heating, ventilation, and air conditioning:

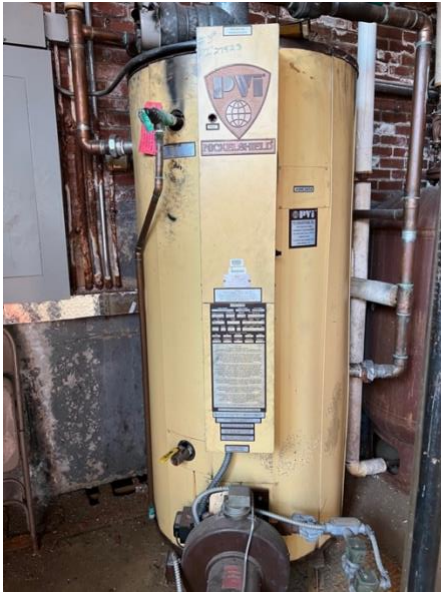
*Figure 7: Bathroom*

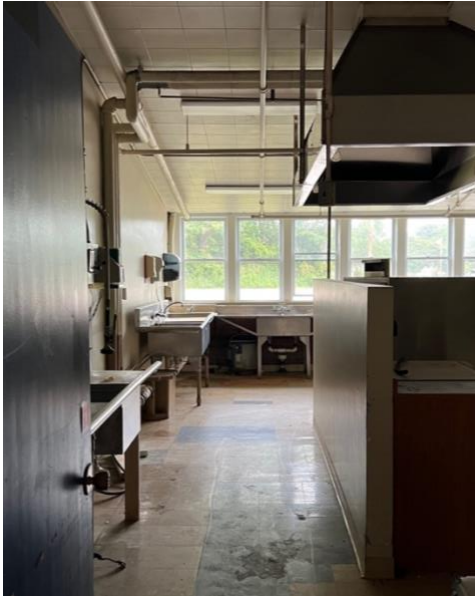
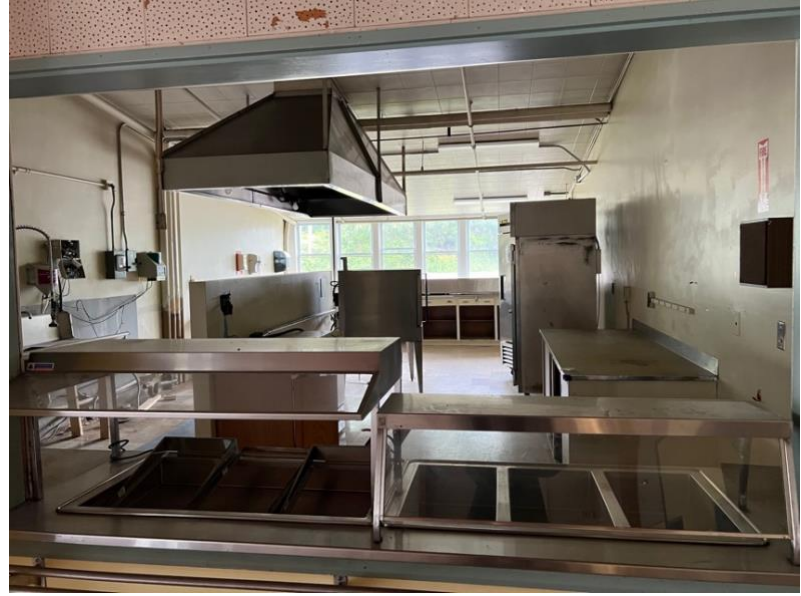
b. Physical Conditions Assessment

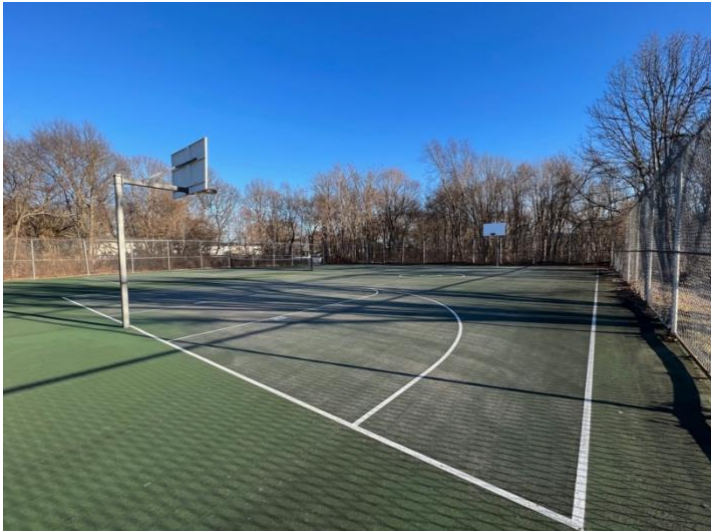
Figure 13: Parking Lot

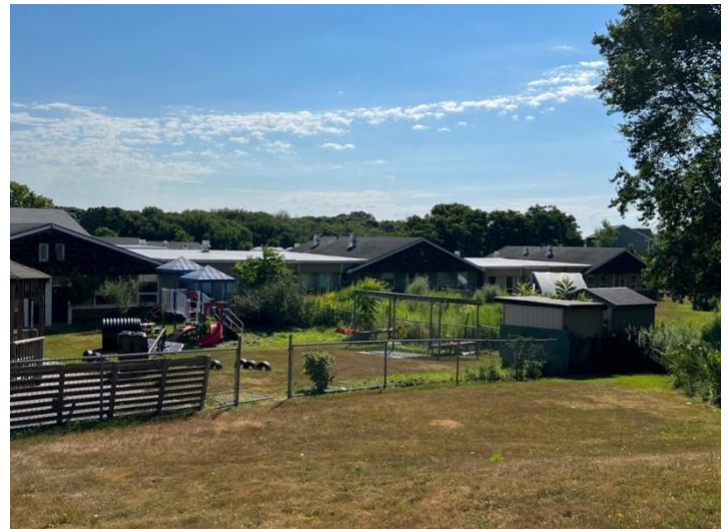
Figure 17: Playground

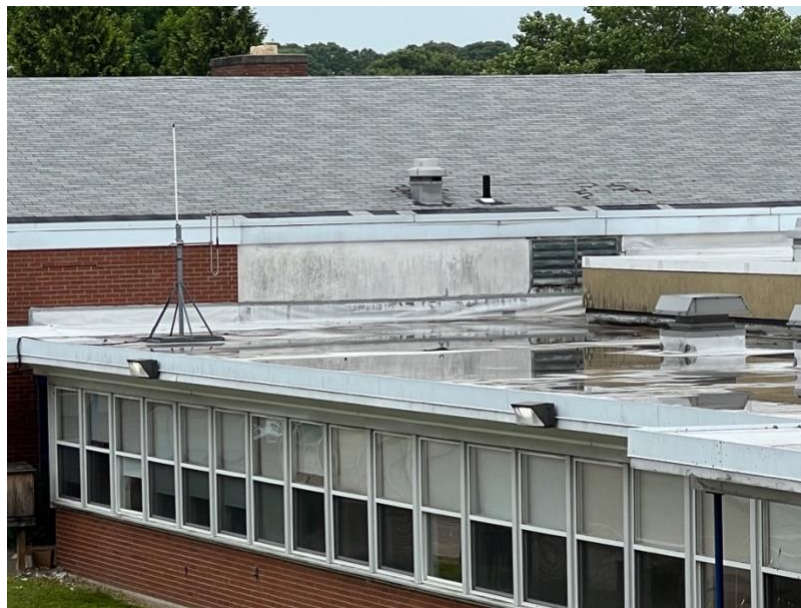
iii. BUILDING ENVELOPE

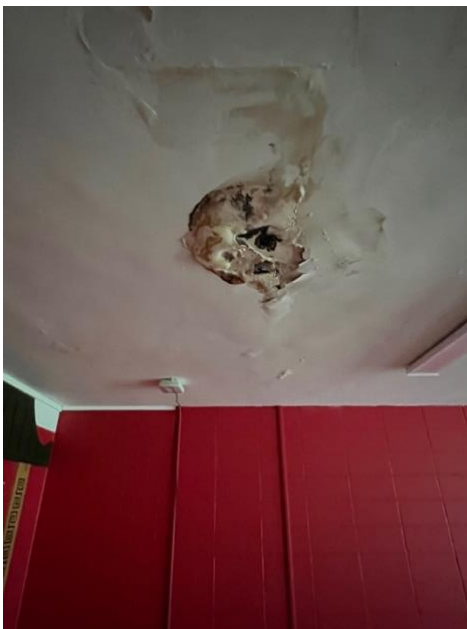
Figure 20: Water damage at door jamb

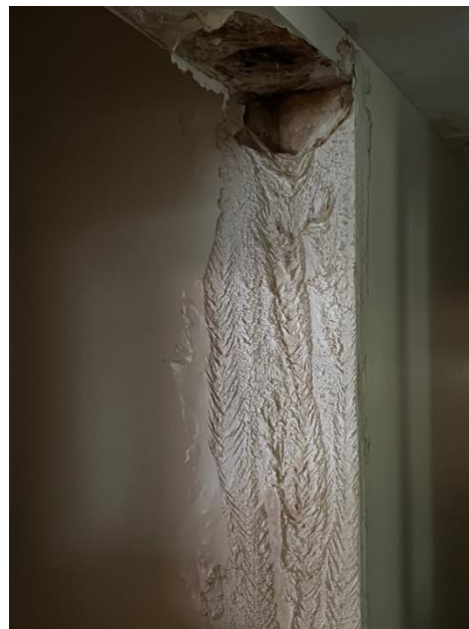
c. Hazardous Materials Summary

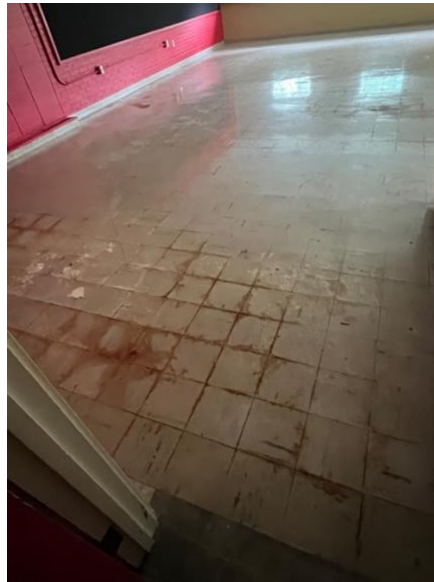
After establishing a baseline understanding of the School’s physical state by way of the Technical Evaluation, the Study progressed to its next stage, the feedback-focused Community Needs Assessment.

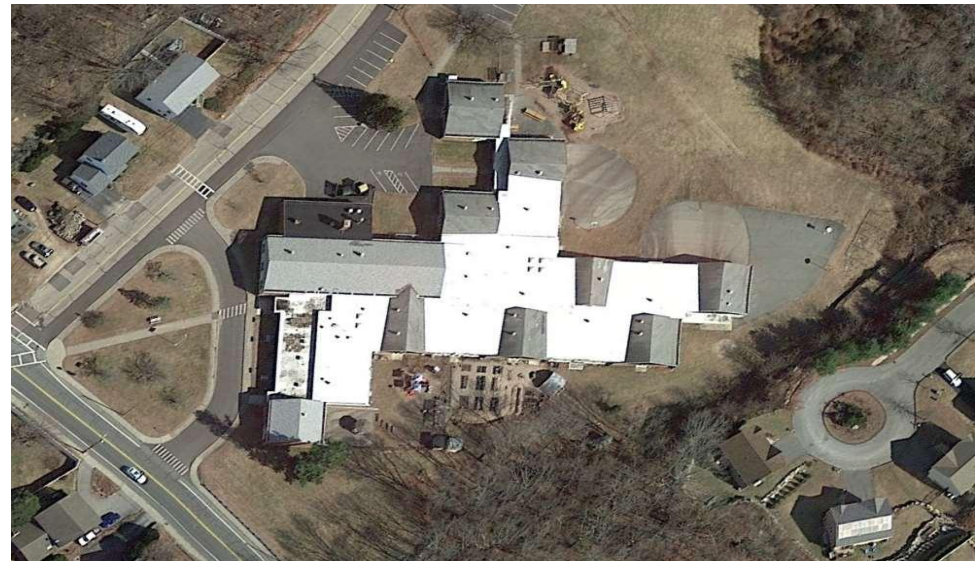
Property Description:

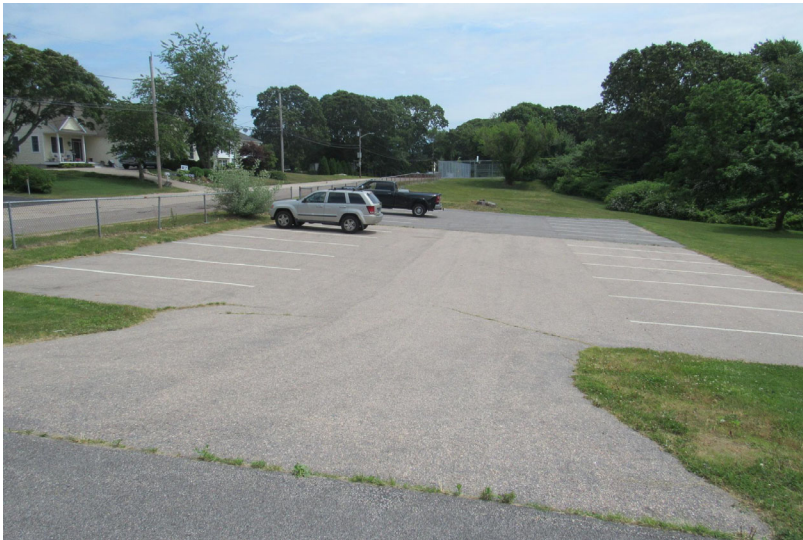
View of asphalt pavement conditions as seen at north end parking area along Narragansett Avenue

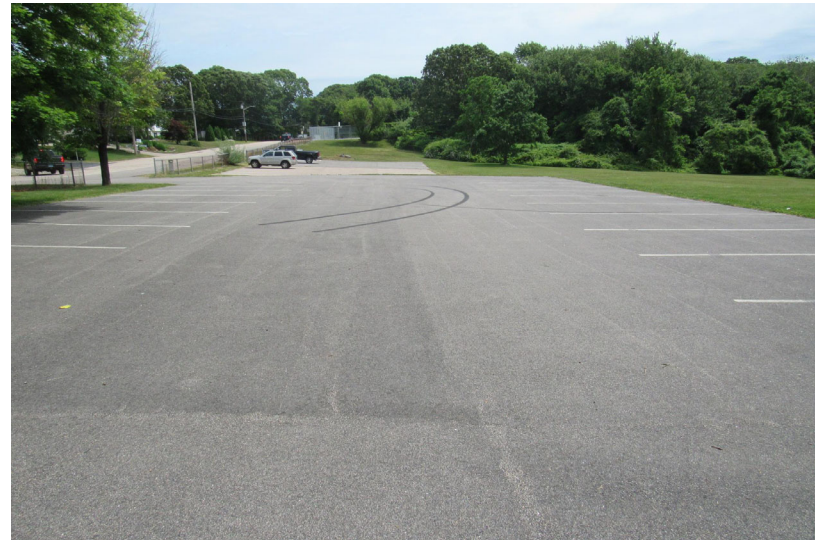
Additional view of asphalt-paved surface parking area conditions – no widespread cracking, depressions, or evidence of fatigue observed

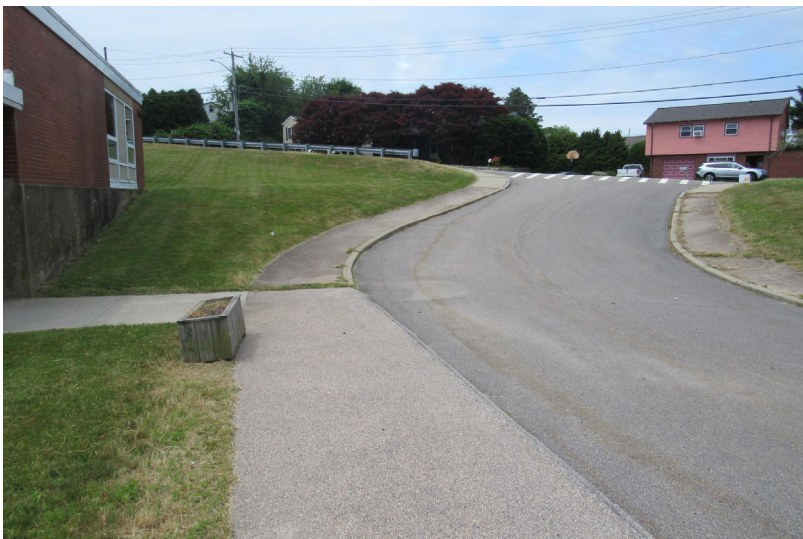
View of asphalt-paved entry roadway conditions as seen towards northwest corner of development

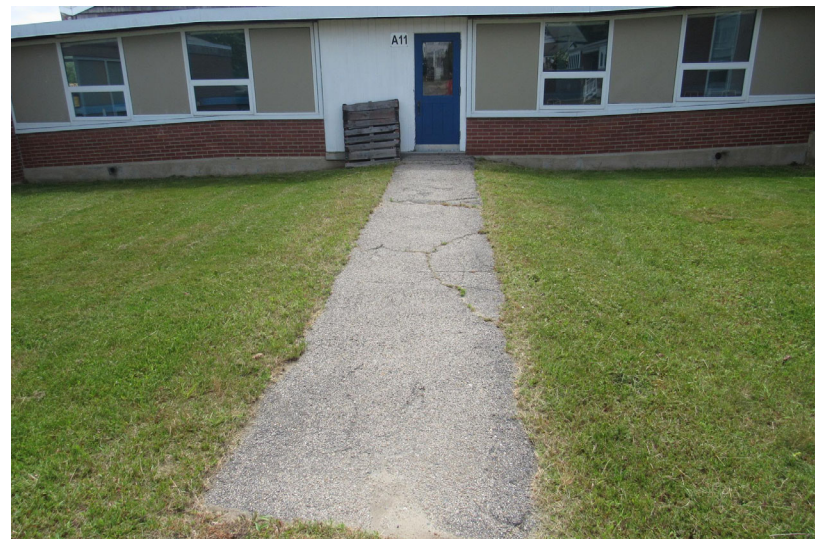
View of localized cracking within asphalt-paved walkway

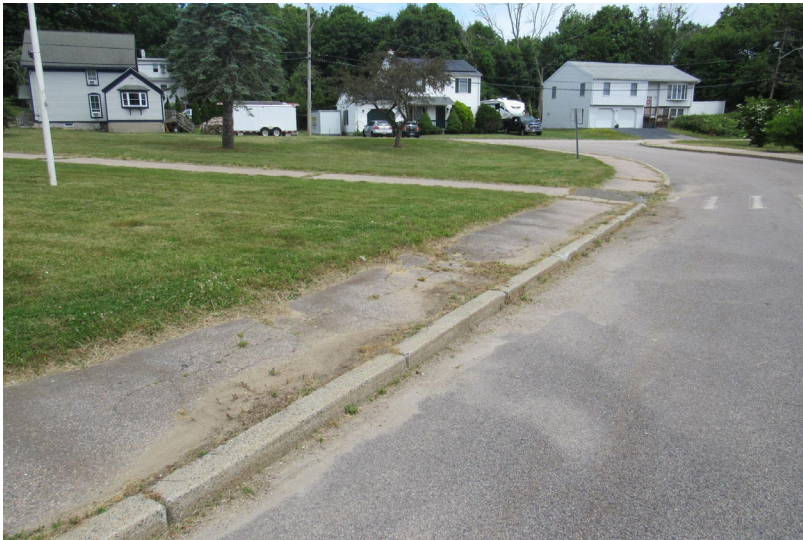
Additional view of asphalt-paved walkway deterioration as seen along front of building

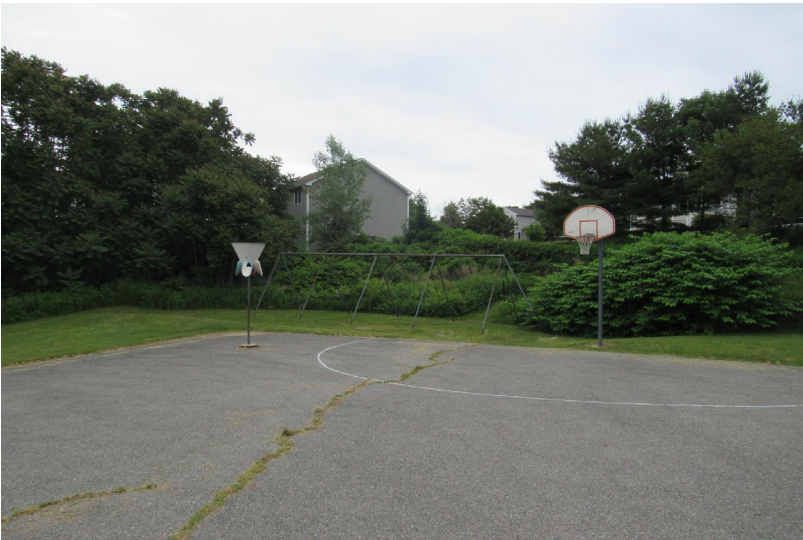
View of asphalt-paved basketball court present at south end of development – localized cracking noted

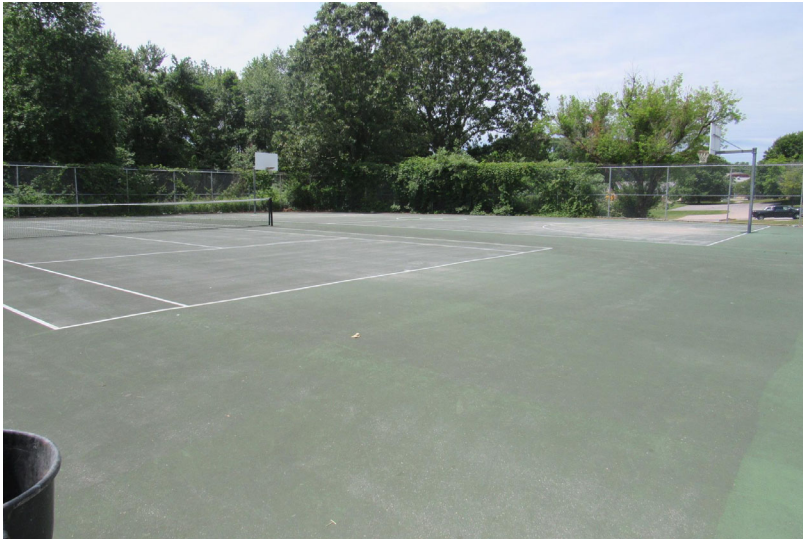
View of tennis and basketball courts and surrounding metal chain-link fencing present towards northeast corner of site

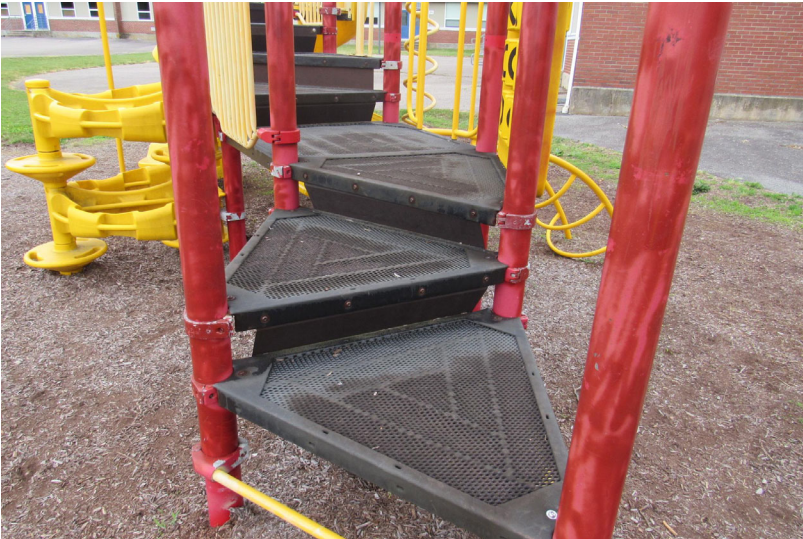
View of sample of children's playground equipment conditions

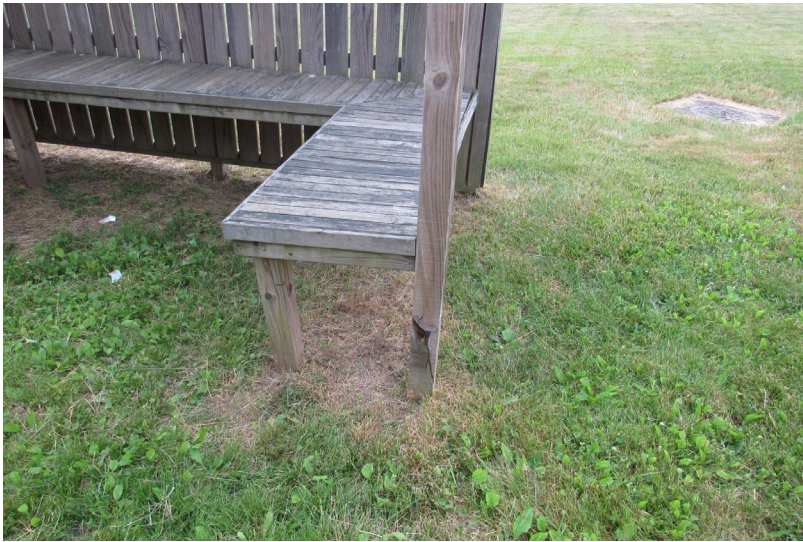
View of wood-framed bench structure exhibiting wear

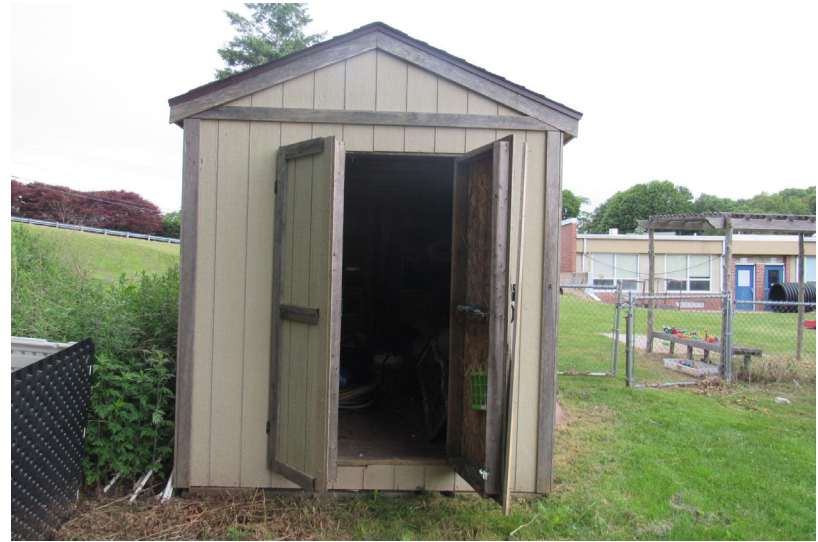
View of rear wood-framed storage shed

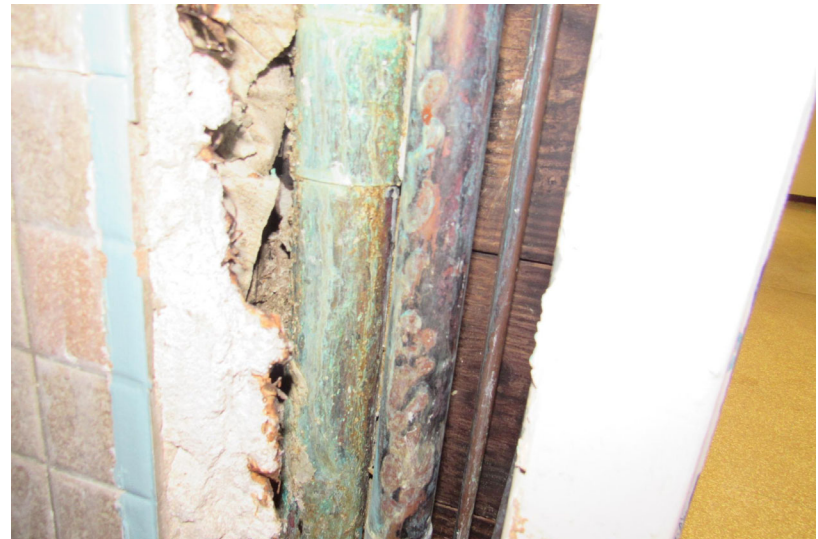
View of sample of distribution piping exhibiting oxidation/wear

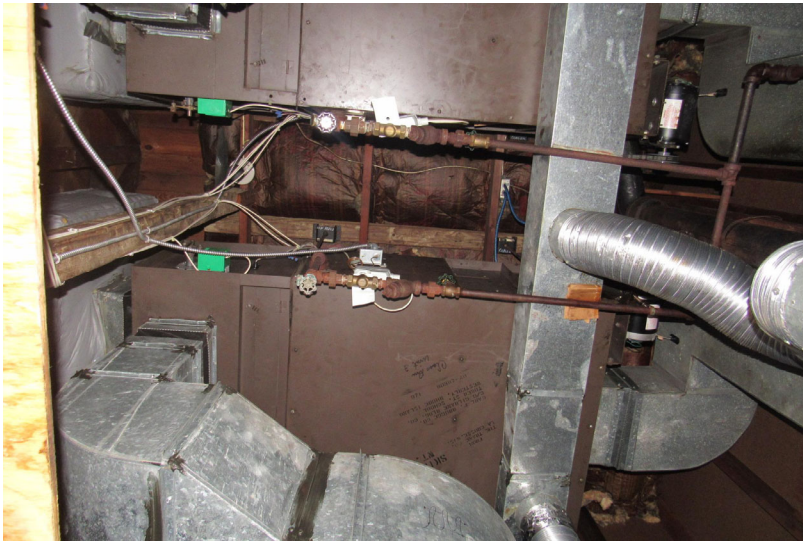
View of one of several interior heating and ventilation units serving rear (i.e., south end) classrooms

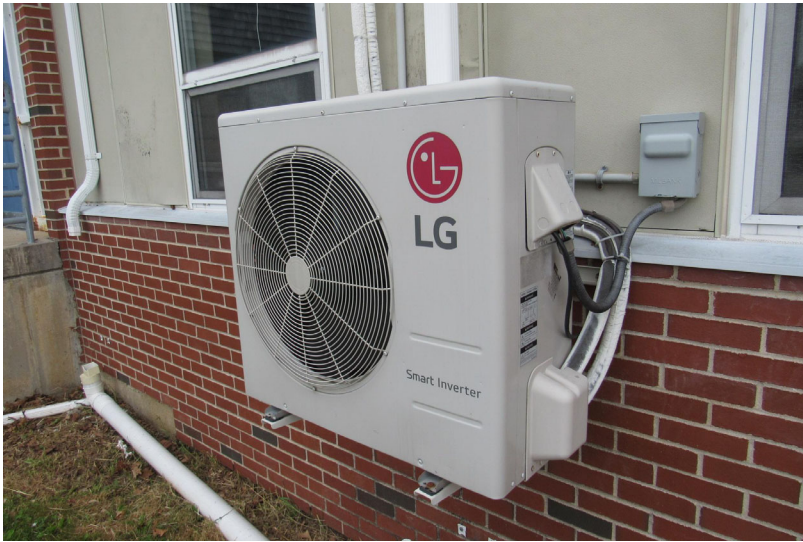
View of LG ductless mini-split system air conditioner

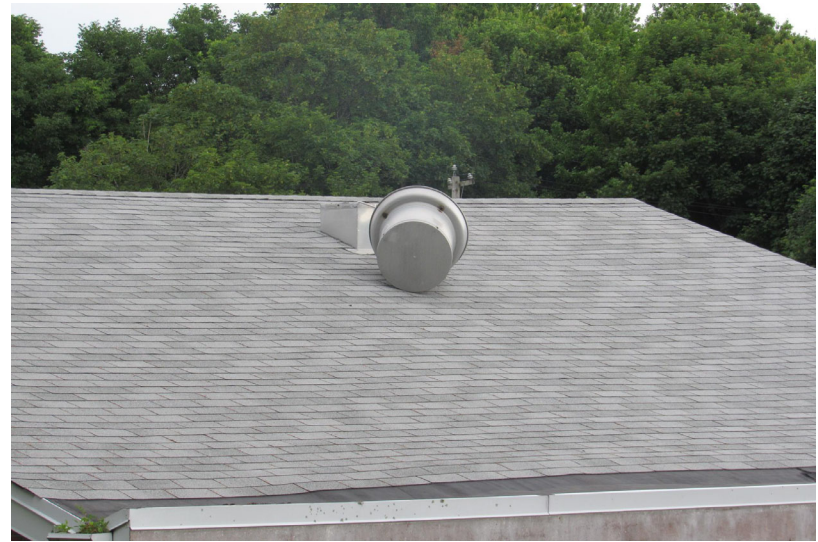
View of displaced rooftop-mounted powered exhauster present at west end of building

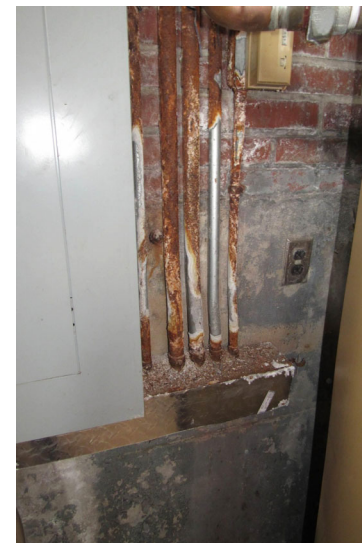
View of corroded electrical conduit present within central mechanical room

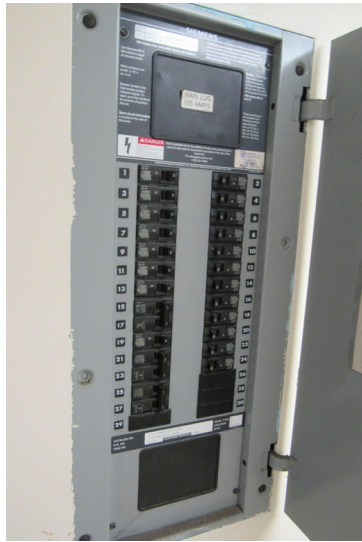
View of one of several electrical circuit breaker panels – mix of newer Siemens panels and possibly original panels

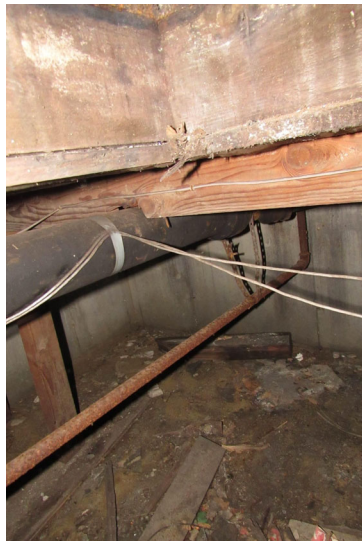
View of sample of building crawlspace conditions

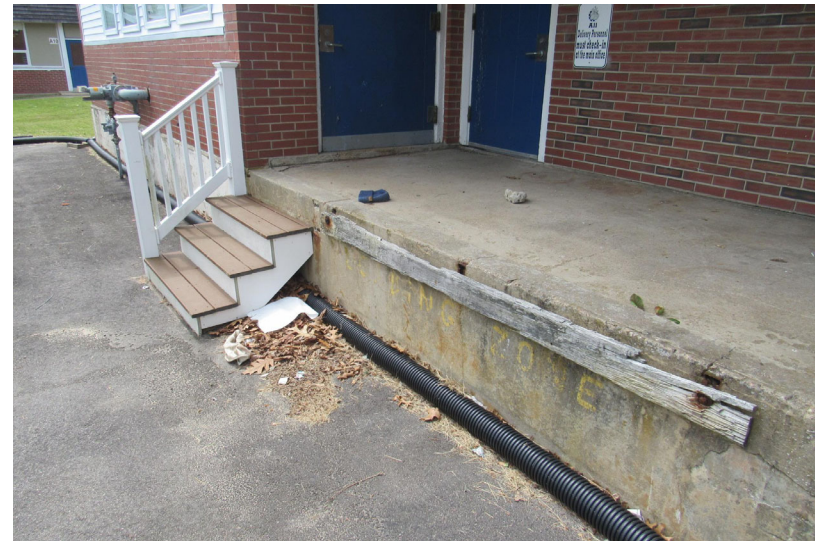
View of concrete loading dock present at north end of building

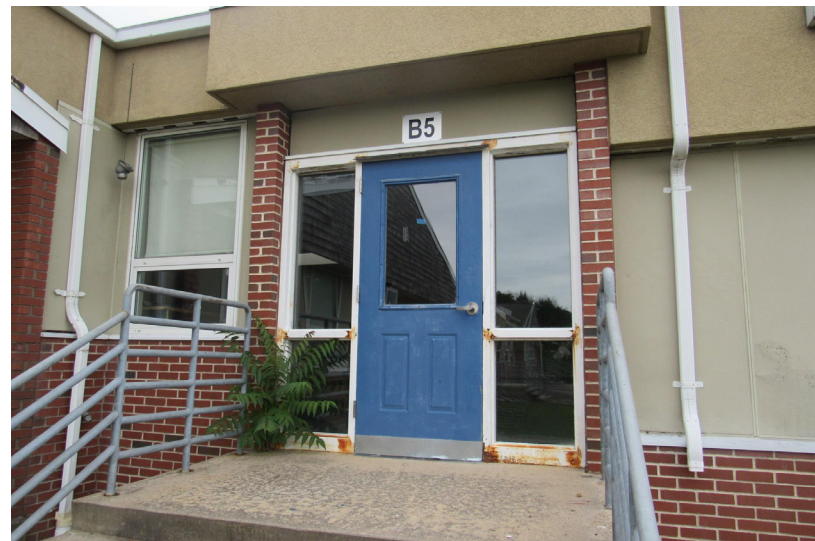
View of embossed two panel metal doorway and metal side lights exhibiting corrosion and age related wear

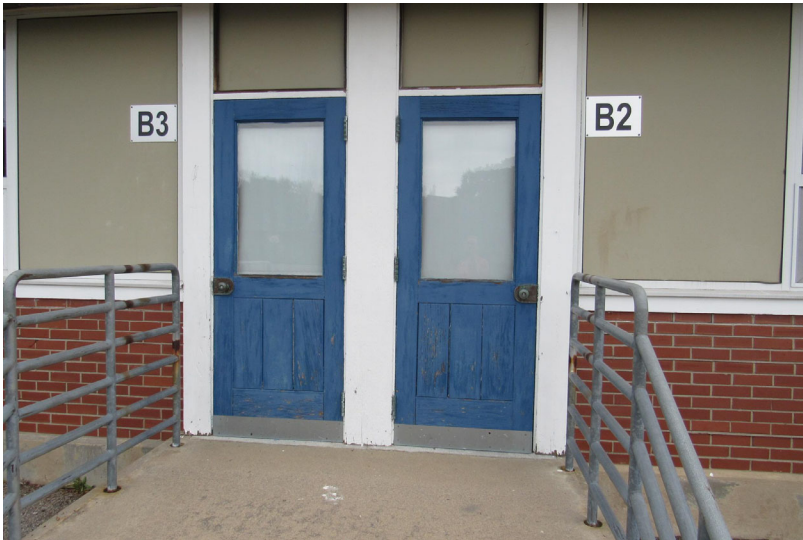
View of solid core wood emergency egress doors exhibiting age related wear

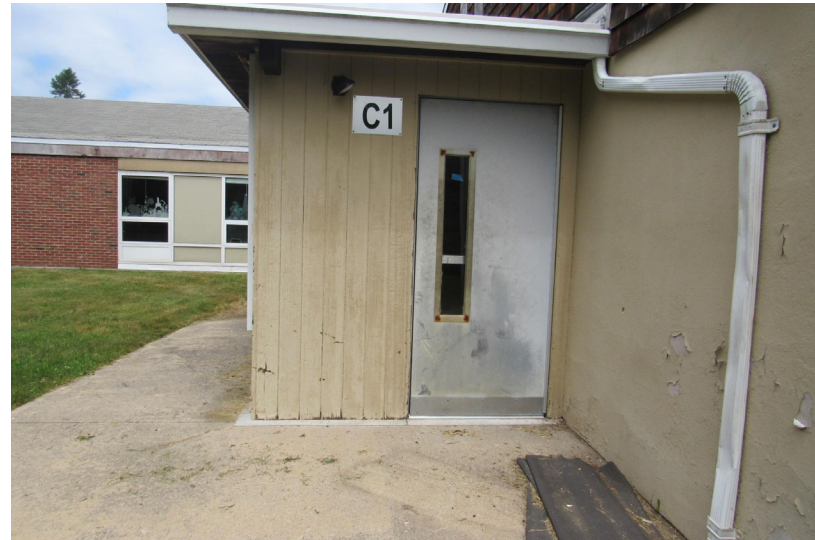
View of hollow metal emergency egress doorway exhibiting abrasions/wear

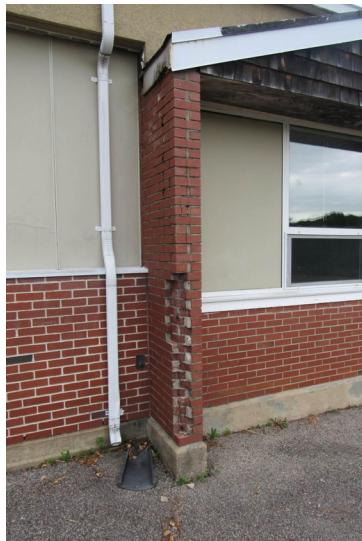
View of pronounced brick masonry deterioration (e.g., mortar loss, spalls, cracking) – observed at several locations

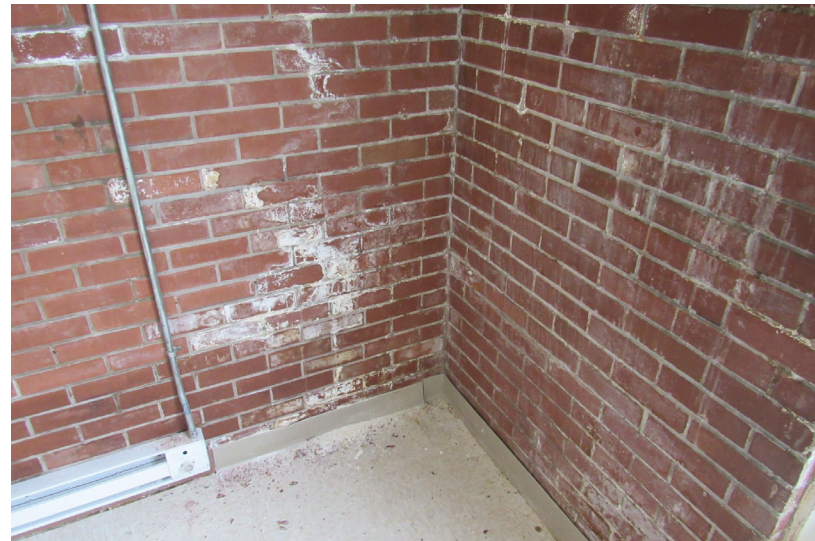
View of apparent efflorescence staining on interior brick masonry surfaces

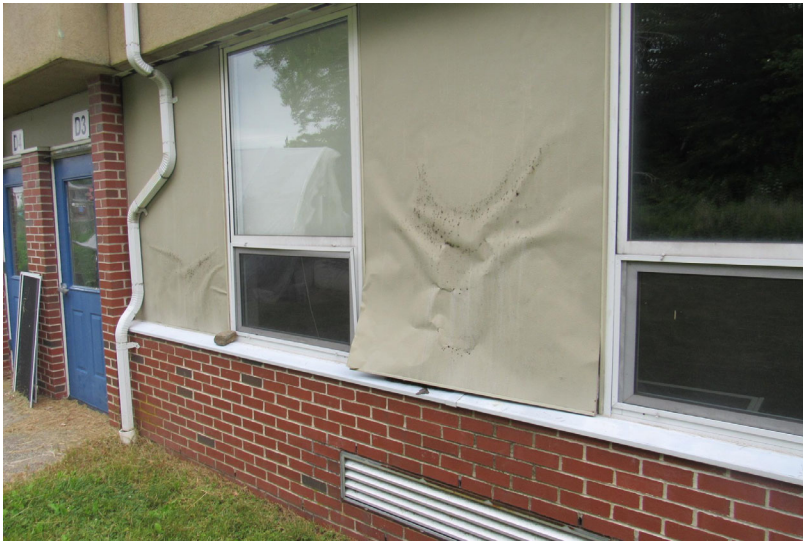
View of damaged metal paneling present at rear of building

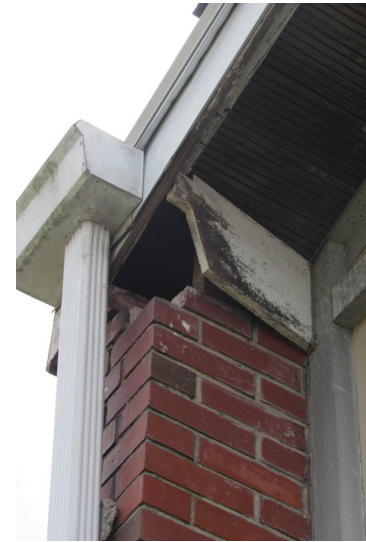
View of void/source of moisture and rodent ingress within building envelope as seen at north end

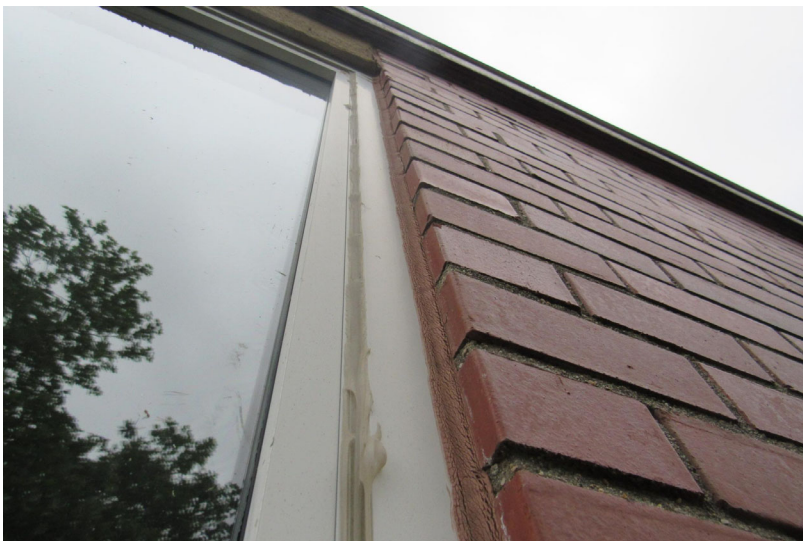
View of exterior window perimeter caulking conditions – note cohesive/adhesive failures

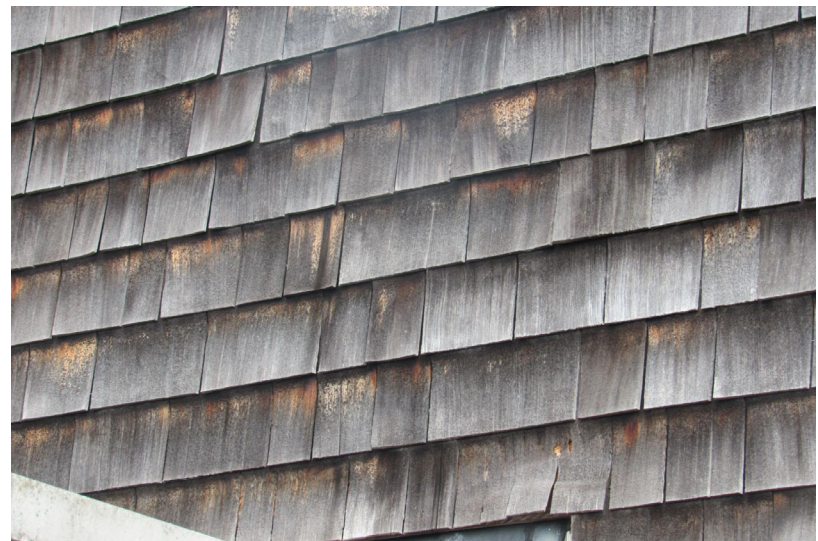
View of wood shake siding exhibiting age related wear

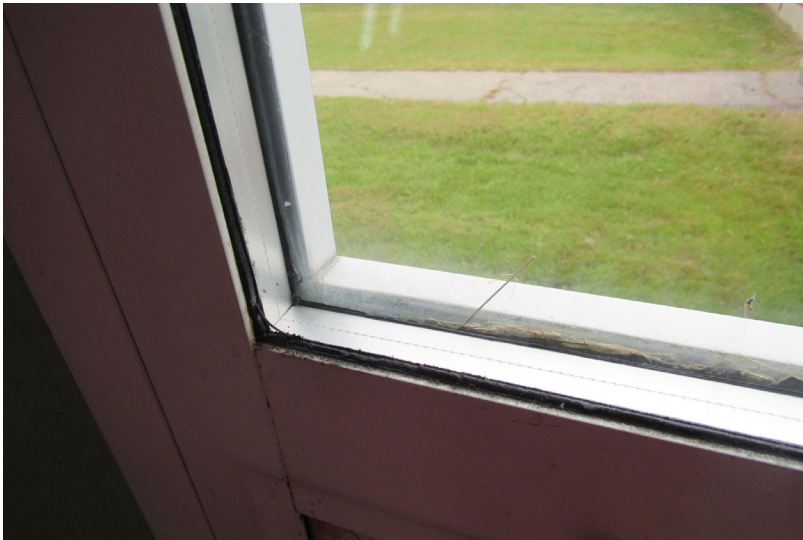
Exterior windows are predominantly aluminum-framed fixed and operable models – butyl bedding compound deteriorated at select locations

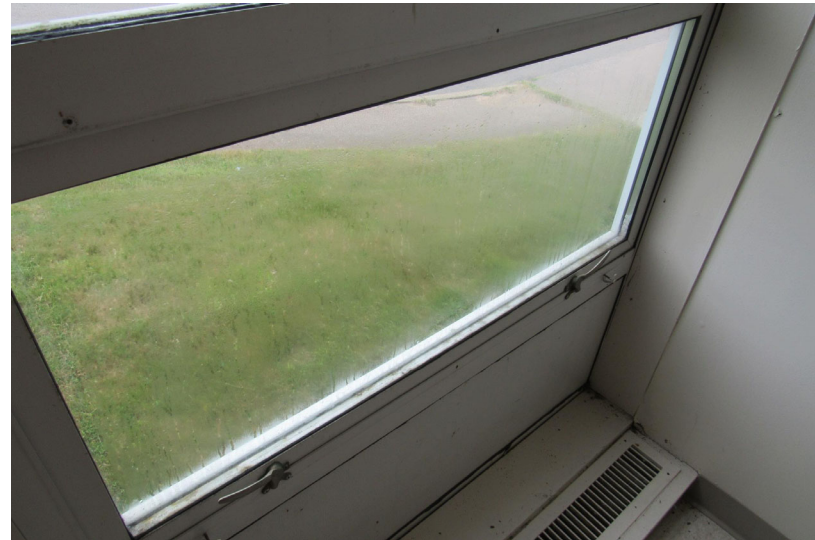
View of failed insulating glass unit (i.e., condensation formation between glass panes)

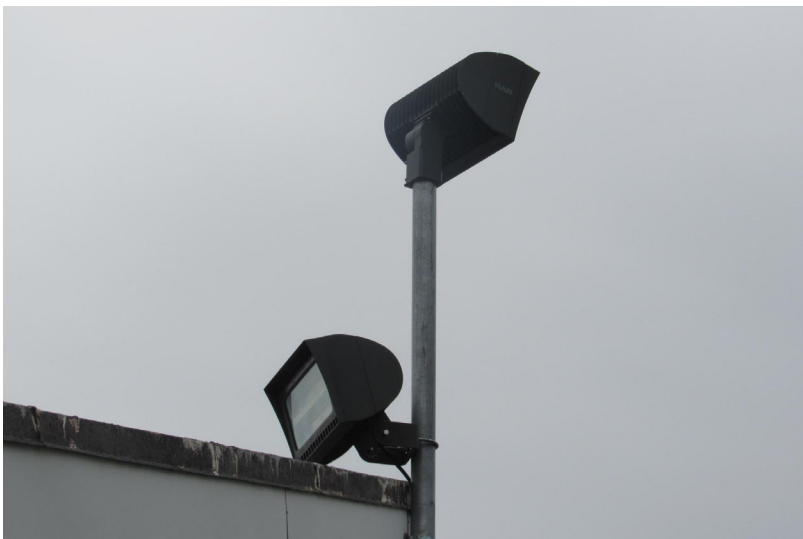
View of building-mounted light-emitting diode (LED) fixtures

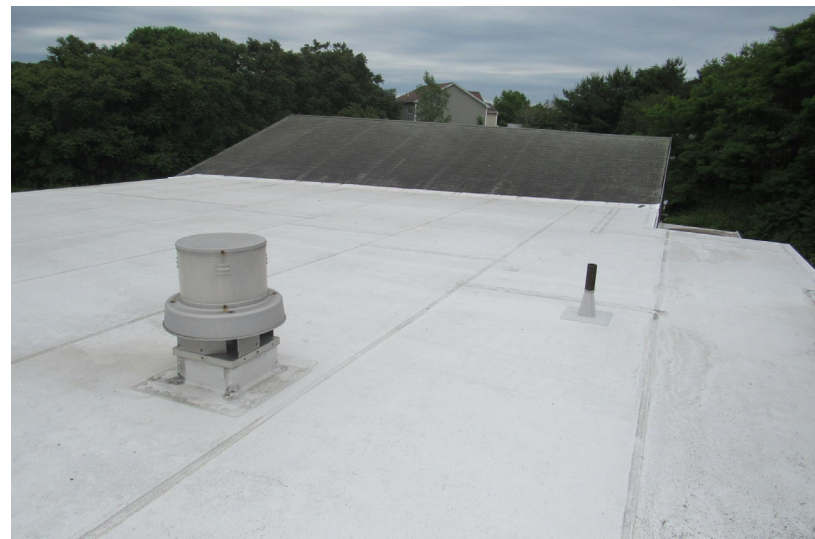
View of single-ply thermoplastic polyolefin (TPO) roof assembly conditions

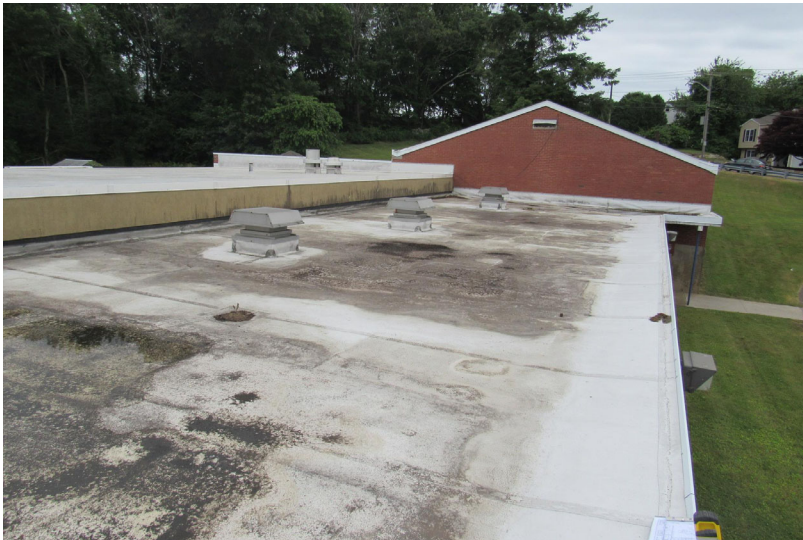
View of widespread staining and evidence of poor drainage on single-ply roof assembly – isolated membrane blisters also noted during site review (i.e., indication moisture has traveled beneath roof membrane)

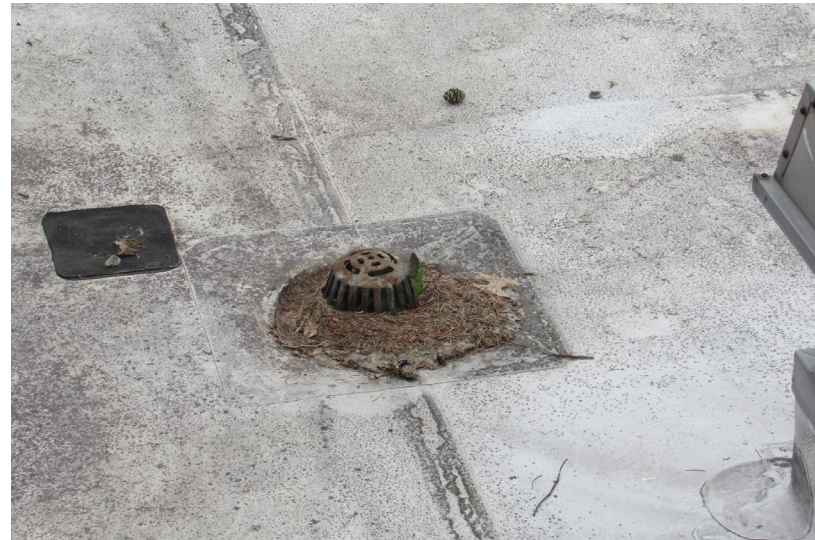
View of accumulated vegetation around strainer dome restricting adequate roof drainage

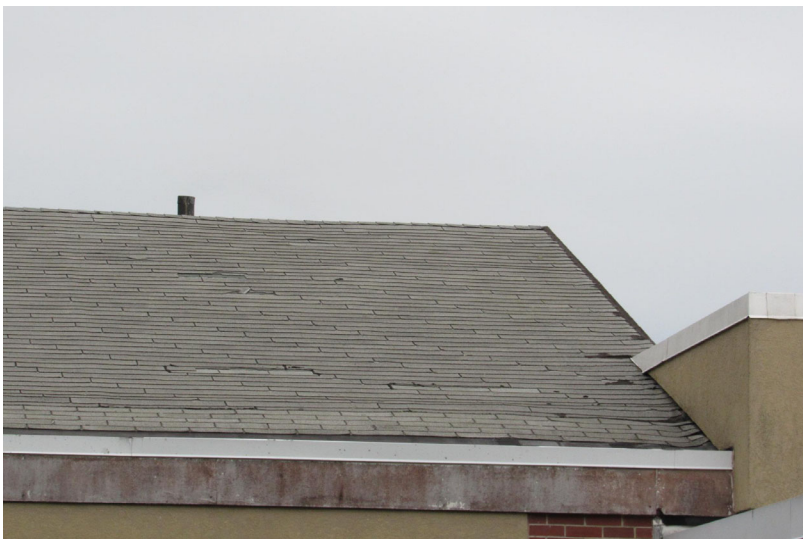
View of displaced three-tab asphalt roof shingles – observed at several locations

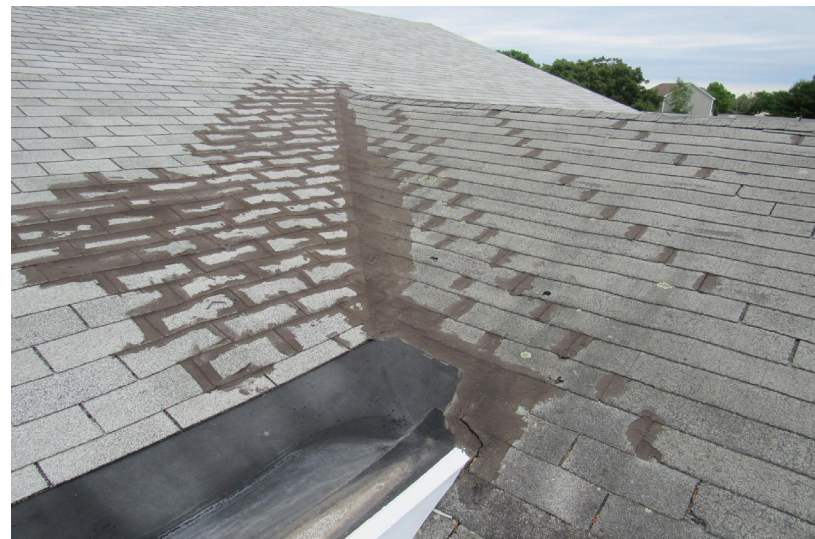
View of evidence of previous mastic-type repairs to roof valley and shingles

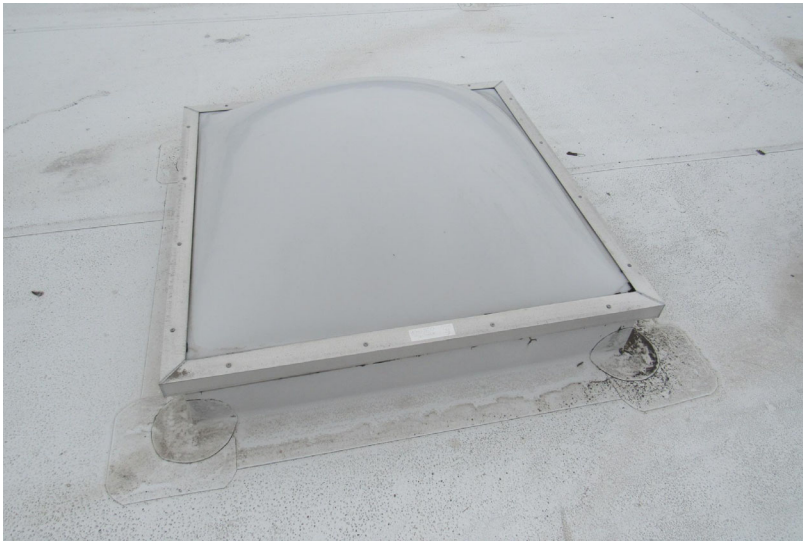
View of typical curb-mounted skylight conditions

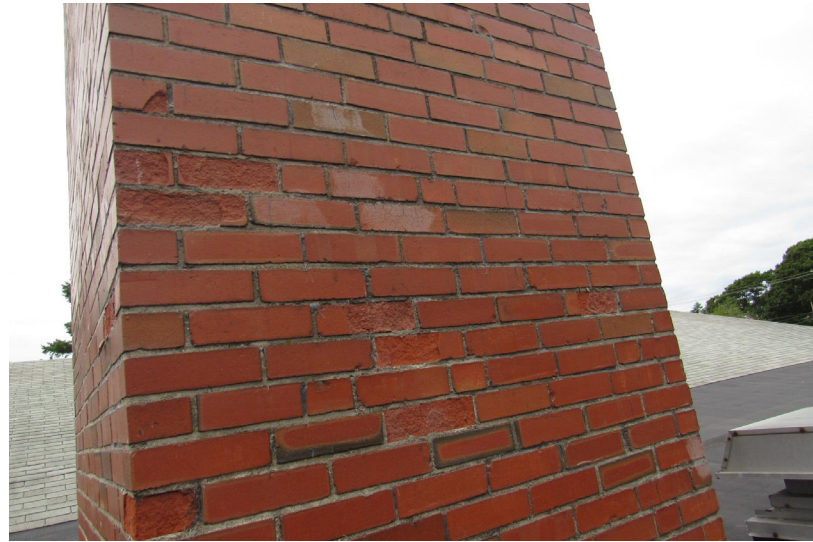
View of deteriorated brick masonry at chimney

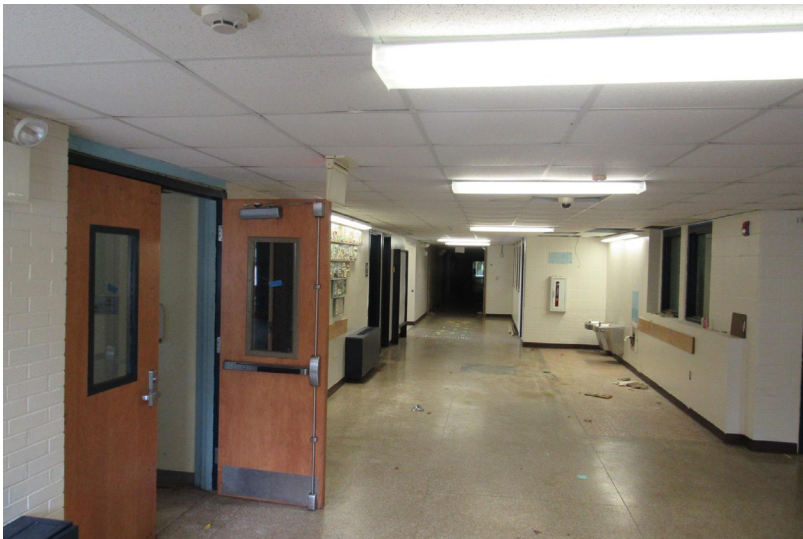
View of typical common hallway finishes

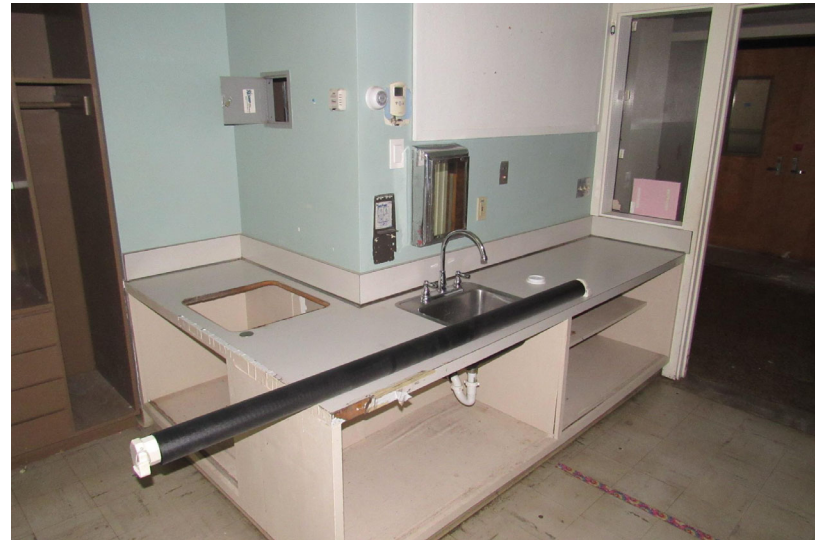
View of sample of classroom cabinetry – age related wear

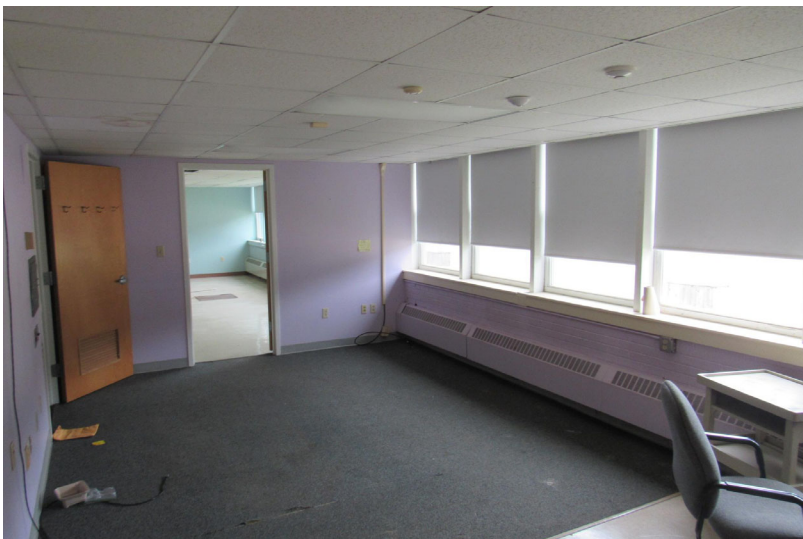
View of sample of office space finishes – mix of vinyl flooring and carpeting

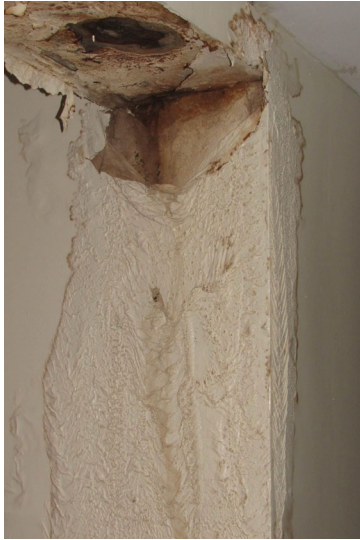
Localized moisture damaged finishes noted within interior spaces – potentially due to roof leakage or failed distribution piping

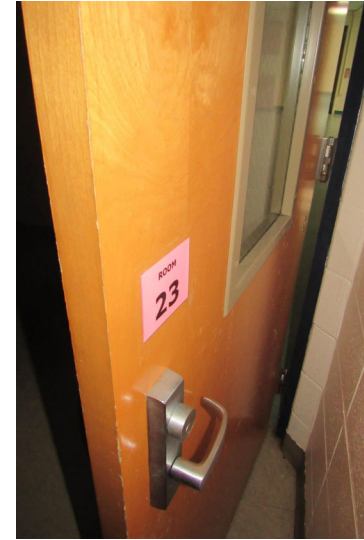
View of typical interior passage doorway conditions

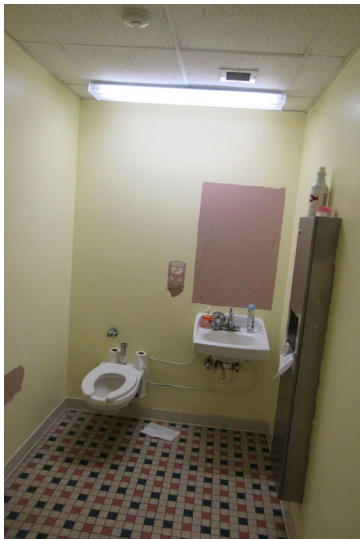
View of sample of common restroom finishes and fixtures – one of several present at facility
