THE ROYCE FAMILY FUND
8 SOUND SHORE DRIVE, SUITE 140 GREENWICH CT 06830
CHARLES M ROYCE, PRESIDENT

THE TOWER STREET SCHOOL REUSE STUDY 2021-2022
SUMMARY REPORT

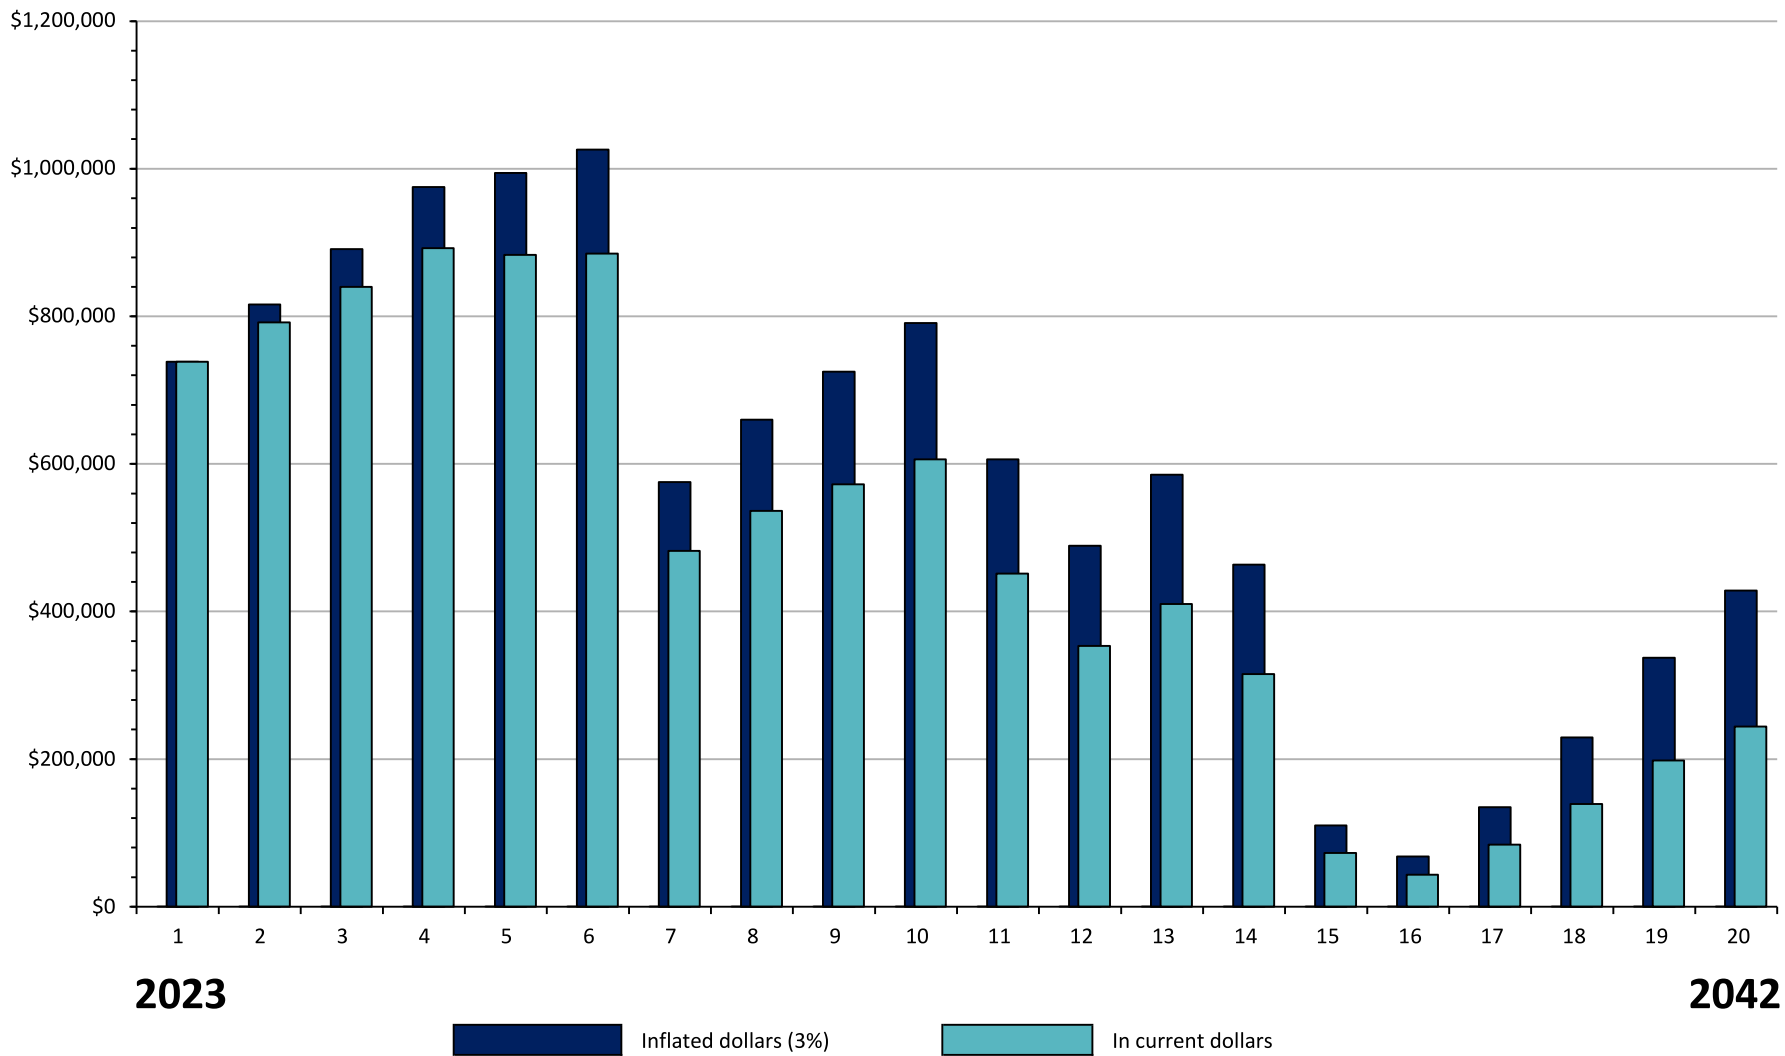
Reported Reserve Balance as of 01/01/2023 : \$0 At the end of Year One, Reserve Balances are projected to be: **\$738,559**
Estimated Reserve Balance as of 01/01/2023 : \$0 At the end of Year 20, Reserve Balances are projected to be: **\$428,498**
Current annual contributions to reserves : \$60,000 **All projected capital needs are met throughout the plan**
